Client: Leslie Lava

Project Address: 11 Mateo Dr., Tiburon, CA 94920

Inspection Date: January 26, 2026

ASSIGNMENT

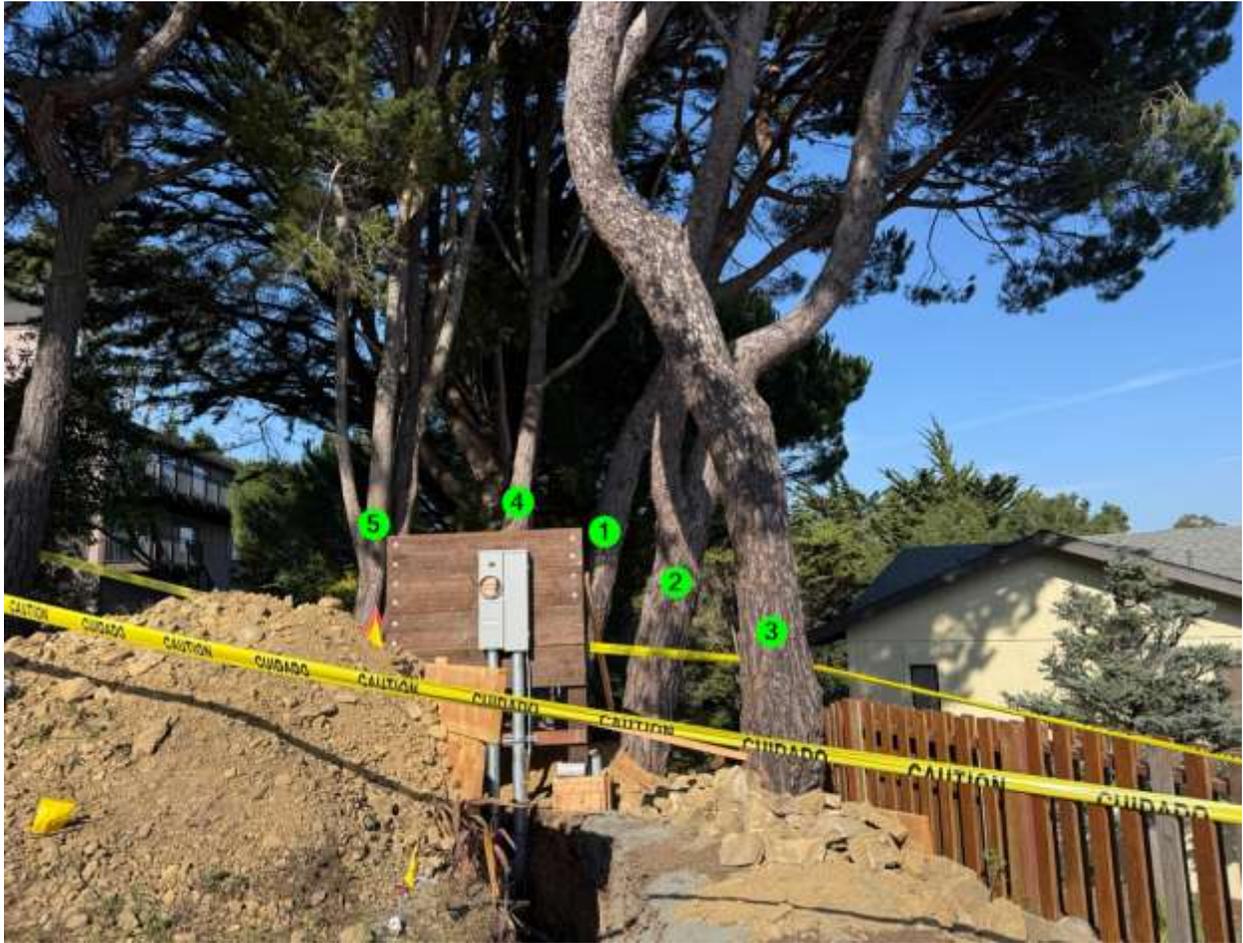
- The subject trees grow in a dense group near the southeast corner of the Lava property, within the front yard, and in close proximity to the residence at 9 Mateo Drive. All trees exhibit good overall health, with varying structural condition and canopy form ratings (Figure 1).

- Tree 1 is an Italian stone pine (*Pinus pinea*) with a trunk diameter of 19.5 inches, located approximately eight feet from the trench. The tree exhibits a pronounced lean to the north and an asymmetric canopy extending toward the neighboring property.

- Tree 2 is an Italian stone pine (*Pinus pinea*) with a trunk diameter of 19.5 inches. It is located approximately two and a half feet from the trench and displays a similarly asymmetric crown. This tree also extends over the adjacent neighbor's front yard.

- Tree 3 is an Italian stone pine (*Pinus pinea*) with a trunk diameter of 19 inches. This tree is located less than two feet from the trench and appears to be situated within the City right-of-way.

- Tree 4 is a Monterey cypress (*Hesperocyparis macrocarpa*) with a trunk diameter of approximately 12 inches, located less than one foot from the trench. The tree is suppressed, with a tall, narrow crown form. A decay cavity is present at a wound located approximately one foot above grade on the north side of the lower trunk.

- Tree 5 is a Monterey cypress (*Hesperocyparis macrocarpa*) with a trunk diameter of approximately 14.5 inches, located roughly two feet from the trench. The tree has a narrow, upright canopy form.

I have recommended the removal of Trees 1 through 5. A permit is required to remove Trees 1 and 2 due to the fact that their trunk circumferences exceed 60 inches. A permit is also required for Tree 3, as it is reportedly located within the Town right-of-way.

The utility trench had the greatest impact on the root systems of Trees 2, 3, and 4, as it ran within three feet of these trees and required the cutting of supportive roots. The contractor advised that this location of the trench was required due to the location of the main PG&E electrical box and also due to a neighborhood safety concern that an alternate path could have ruptured a PG&E gas line. In addition, the asymmetric crown architecture of Trees 1 through 3, combined with their target zone over the neighboring property, further increases their risk profile.

Trees 1 and 2 were also affected by the trench; however, root pruning alone was not the sole basis for recommending removal. Rather, removal is recommended due to the combined effects of root loss and the suboptimal pre-existing conditions of each tree, including pronounced trunk lean and asymmetric crown development.

Tree 5 is recommended for removal due to its proximity to the trench and for aesthetic reasons. Removal of Trees 2 and 3 will leave Tree 5 newly exposed, which will further negatively accentuate its already suboptimal crown form.

Figure 1. Trees slated for removal

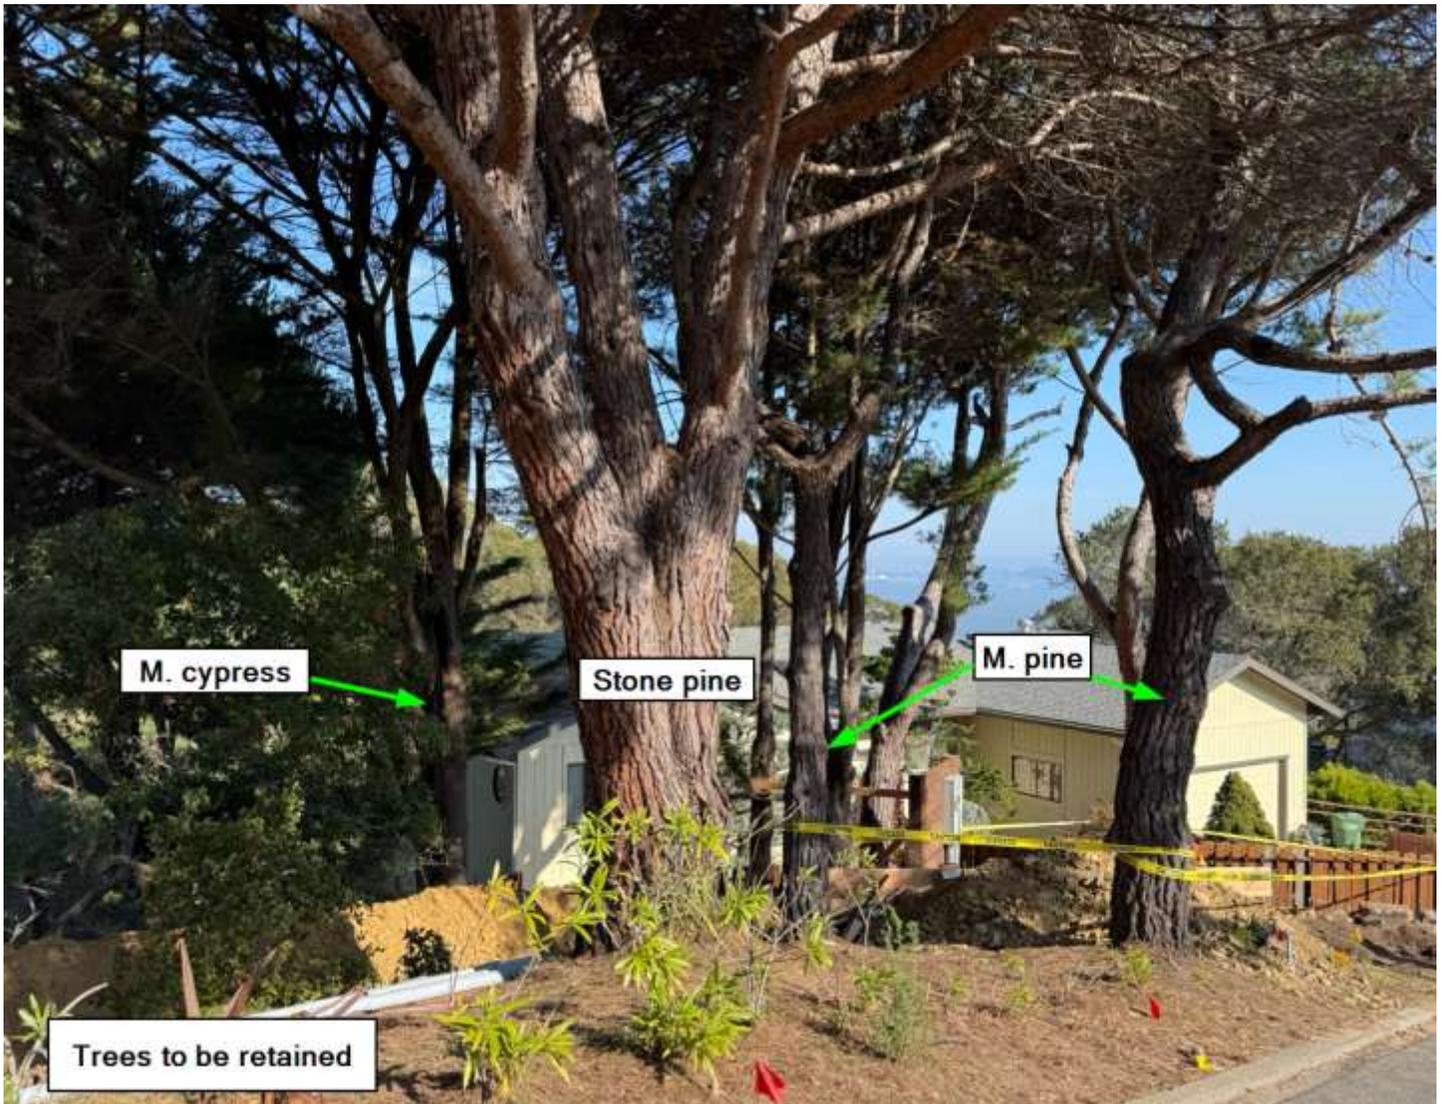
Figure 2

- Four additional trees are present within this group, including two Monterey pine (*Pinus radiata*) trees with trunk diameters of approximately 13.5 inches and 20 inches, located between the street and the trench at distances of approximately 15 feet and 8 feet from the trench, respectively; one Italian stone pine with a trunk diameter of approximately 36 inches located about 10 feet from the trench; and one Monterey cypress with a trunk diameter of approximately 24 inches located near the property boundary downslope from Tree 1 and approximately 10 feet from the trench (Figure 2).

The trenching occurred well outside the critical root zones of the remaining trees in the vicinity, and therefore had a negligible impact on their structural stability. These trees include two Monterey pine trees, one Italian stone pine, and one Monterey cypress.
