## Arborist Report

**Client:** Prudence and Fred Starr  
**Site Address:** 160 Leland Way, Tiburon, CA 94920

**Date of Inspection:** January 21, 2026

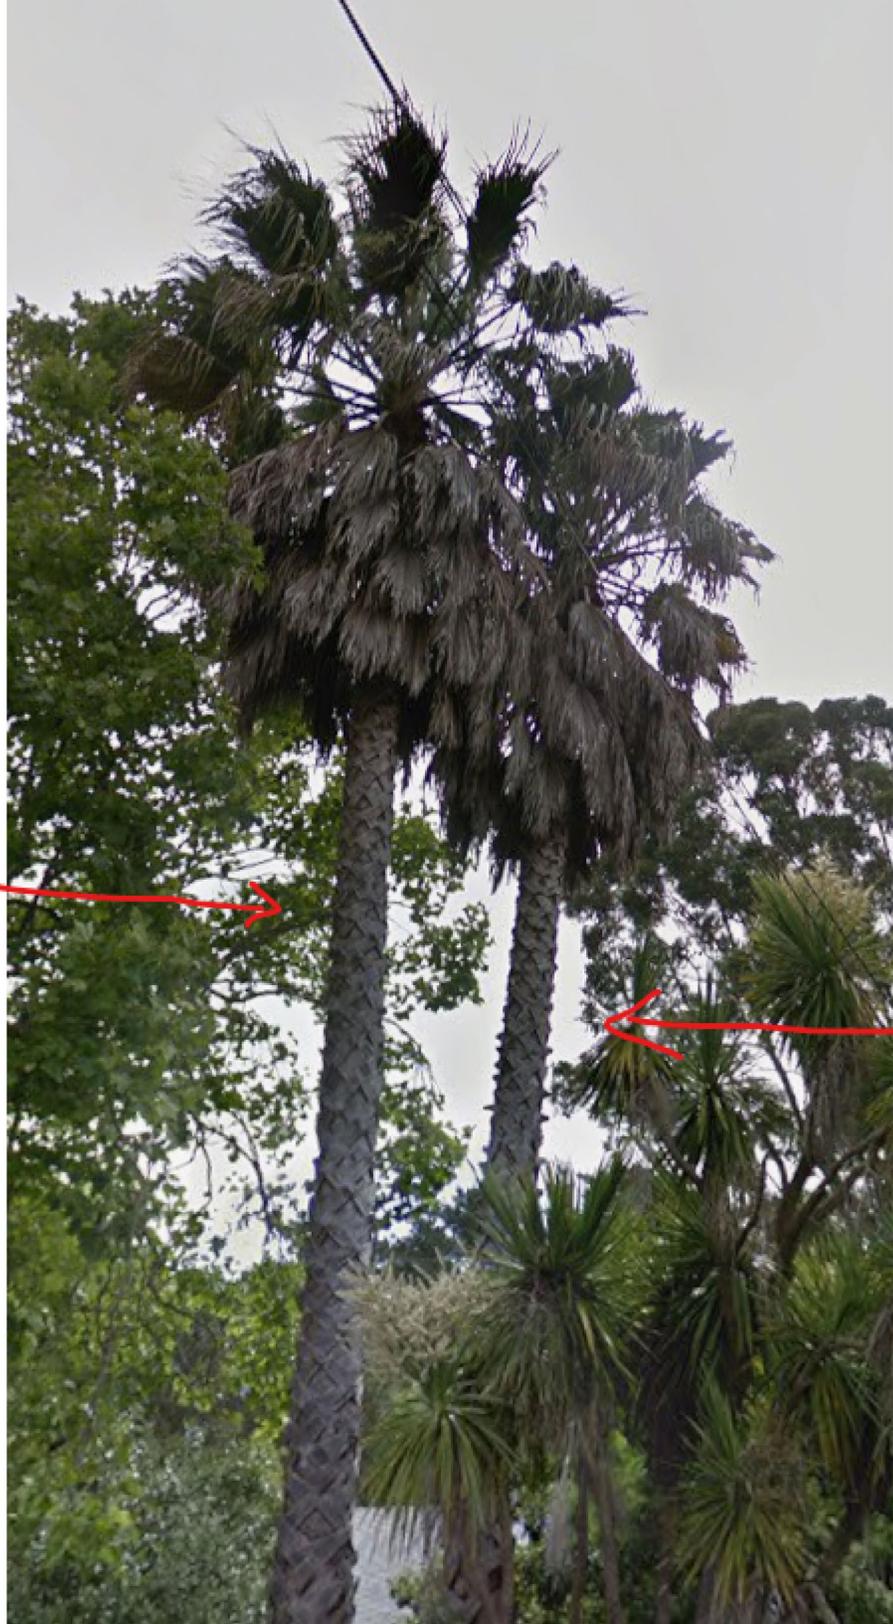
- Exhibits a **more upright growth habit** and currently presents less immediate structural risk.
- Located in **close proximity to overhead telephone wires**, requiring ongoing clearance and increasing long-term maintenance conflicts.
- Root system also extends over **sewer laterals, water lines, and drainage canals**, presenting similar concerns for underground infrastructure damage.

1. **Remove Tree #1 (leaning palm)** due to structural instability and risk to the residence.
  2. **Remove Tree #2 (upright palm)** due to conflicts with overhead utilities and shared risks to underground infrastructure.
  3. If replacement planting is desired, select **appropriately sized, site-compatible species** with non-invasive root systems suitable for proximity to utilities and structures.
-

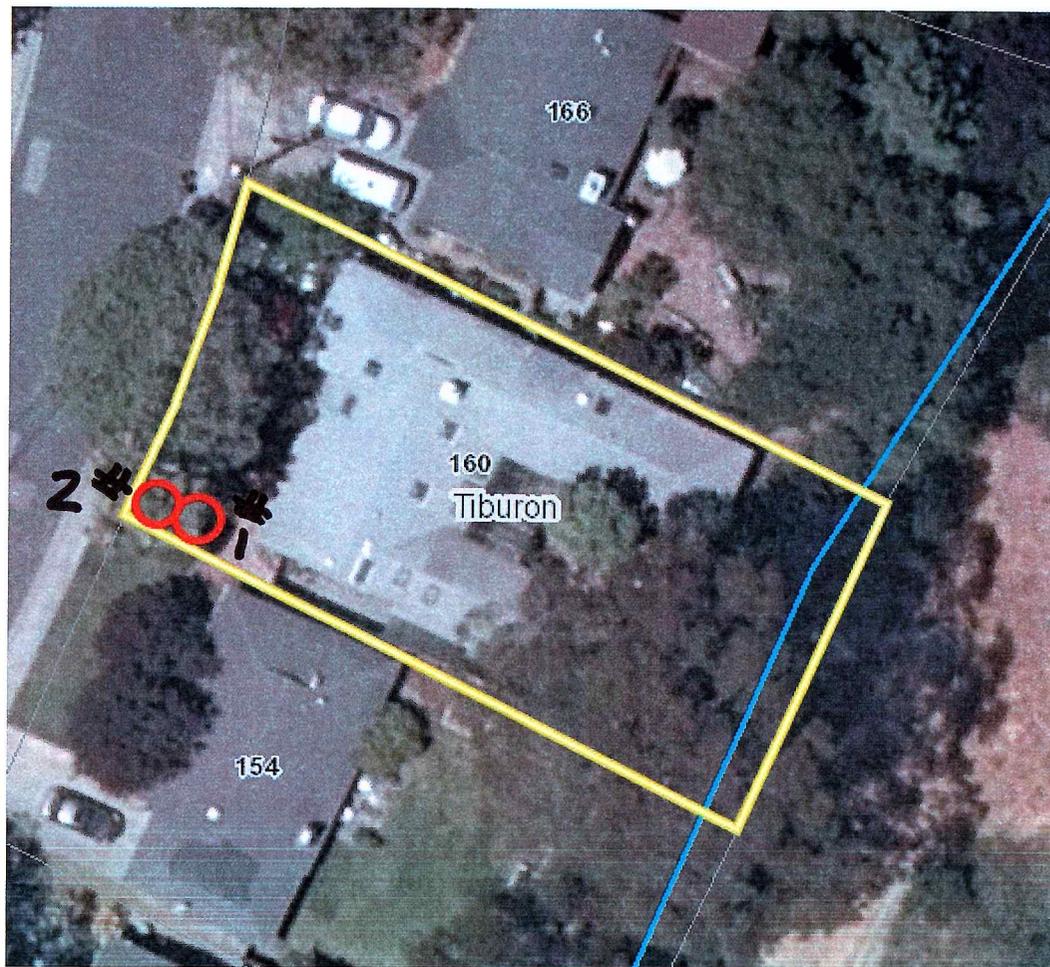
#1

- Exhibits a **pronounced hard lean toward the residence.**

- The direction and severity of the lean place the tree within falling distance of the home should structural failure occur.
- Due to the biological and structural characteristics of palm trees, **corrective pruning cannot mitigate or correct the lean.**
- The root zone extends directly over **sewer laterals, water lines, and drainage canals**, increasing the likelihood of damage to underground utilities.
- The client has expressed concern regarding the potential for failure and resulting property damage.

- **Tree #1:** Presents a **moderate to high risk** due to its significant lean toward the residence and inability to be mitigated through pruning or corrective measures.
- **Tree #2:** Presents a **moderate risk** due to proximity to overhead utilities and shared underground infrastructure concerns.
- Retention of either tree increases the potential for **property damage, utility failure, and future hazard conditions.**
